# Debris/Ice/TPS Assessment And Photographic Analysis For Shuttle Mission STS-44

Gregory N. Katnik  
NASA/Kennedy Space Center

November 24, 1991

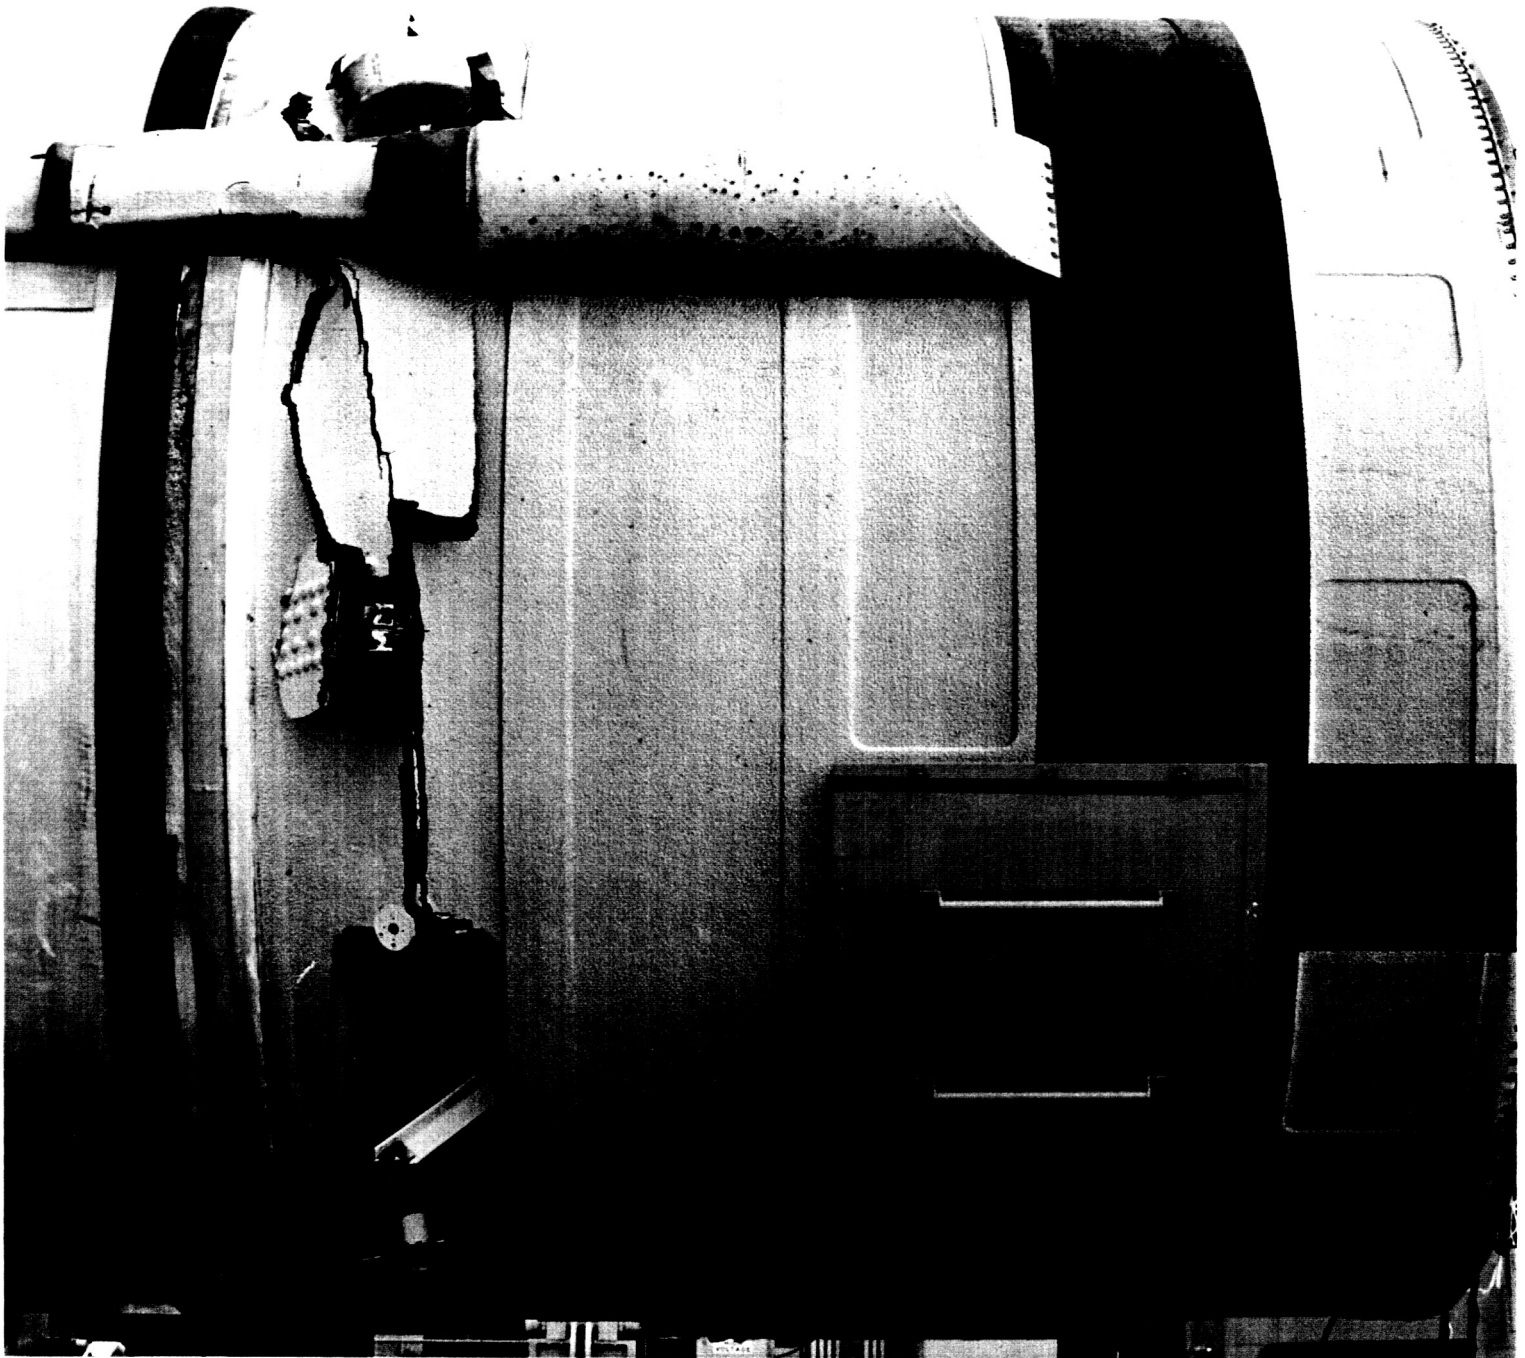
The LH forward skirt, LH forward segment, and LH forward center segment sustained structural damage from either water impact "slap down" loads or parachute deployment side loads. The LH forward assembly was fractured 180 degrees of the circumference. Eight buckles, dents, and flat spots were found in the forward and forward center segments. The forward, forward center, and aft center segments also exhibit out-of-round conditions. Initial assessment indicates the damage was not a source of debris nor was caused by a debris problem.

The LH forward skirt, LH forward segment, and LH forward center segment sustained structural damage from either water impact "slap down" loads or parachute deployment side loads. The LH forward assembly was fractured 180 degrees of the circumference

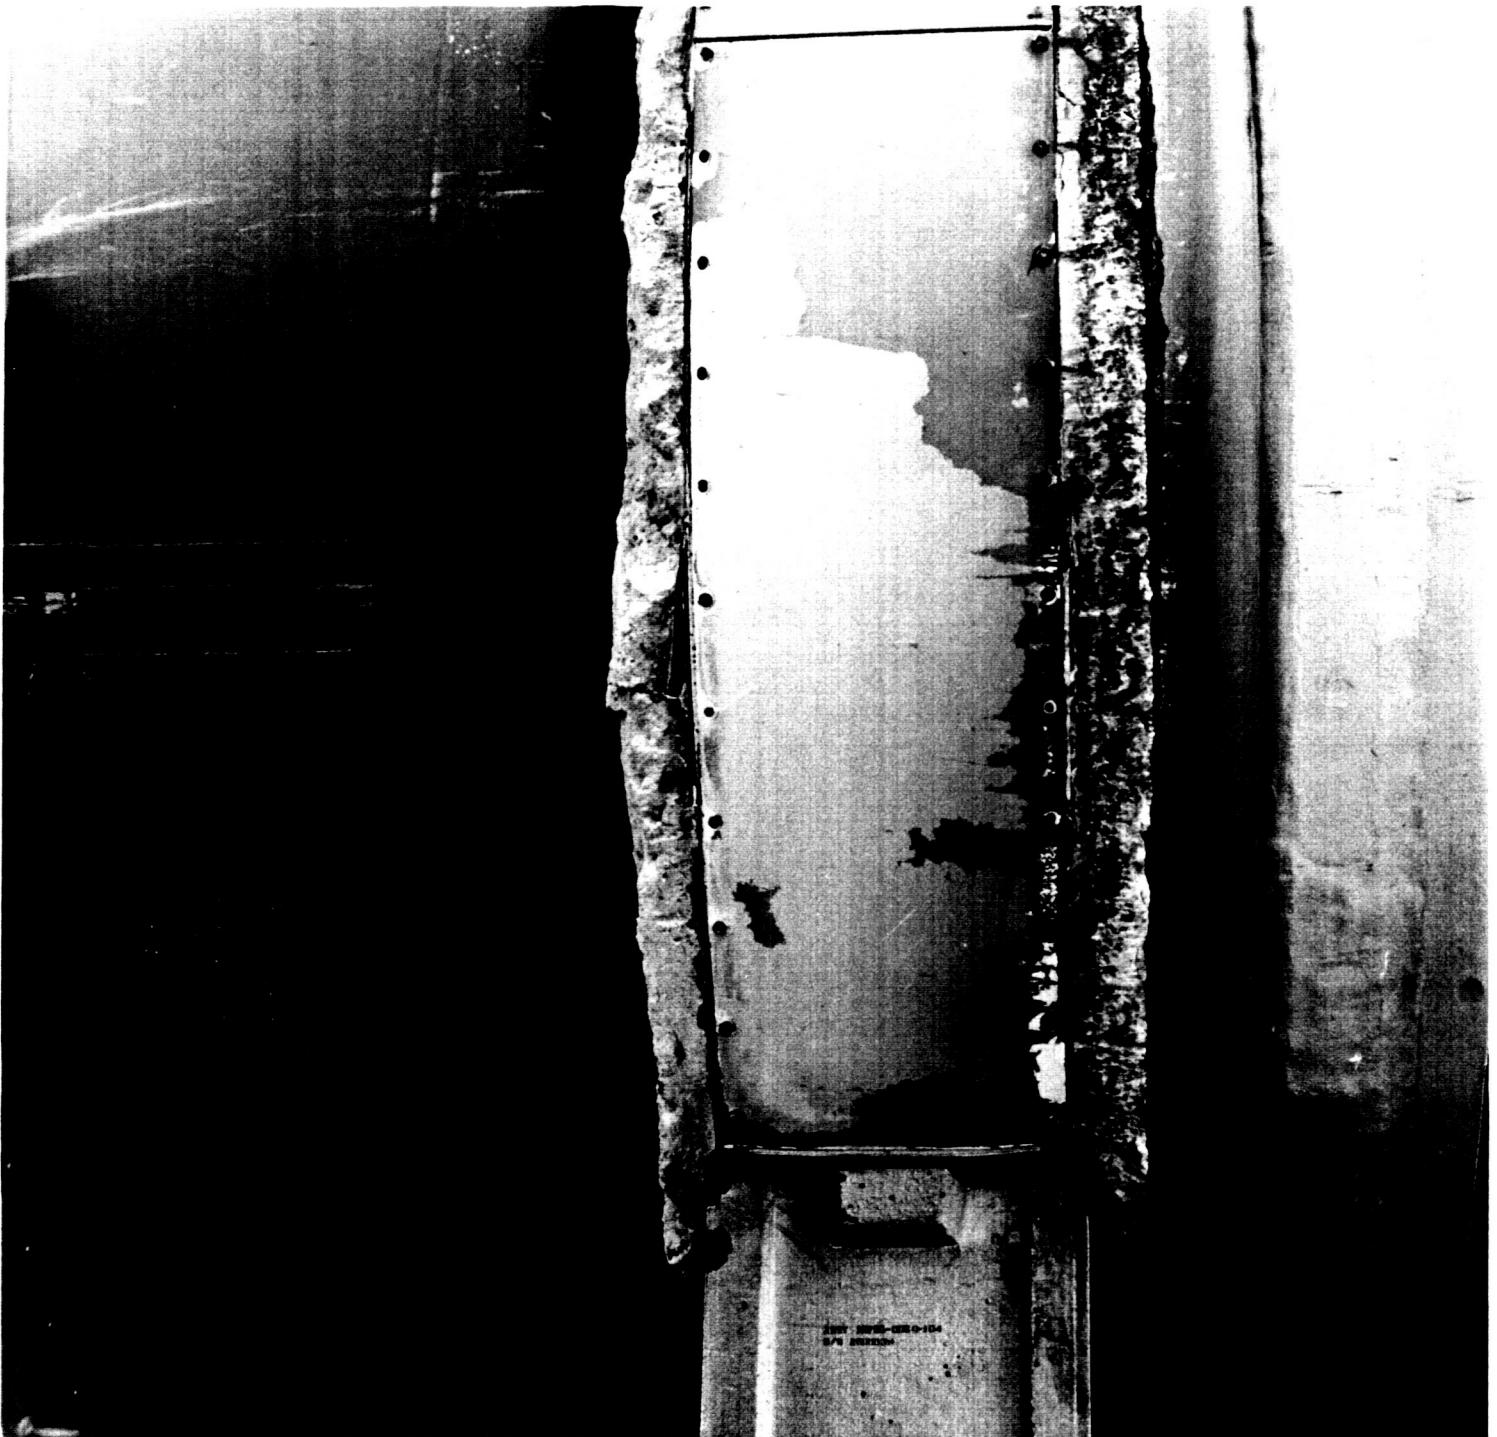
All four of the ETA ring segments and ring stubs on the segment case were damaged. Numerous bolt heads from the ETA ring covers were sheared off. All of this damage may be related to the cause of the forward assembly damage.

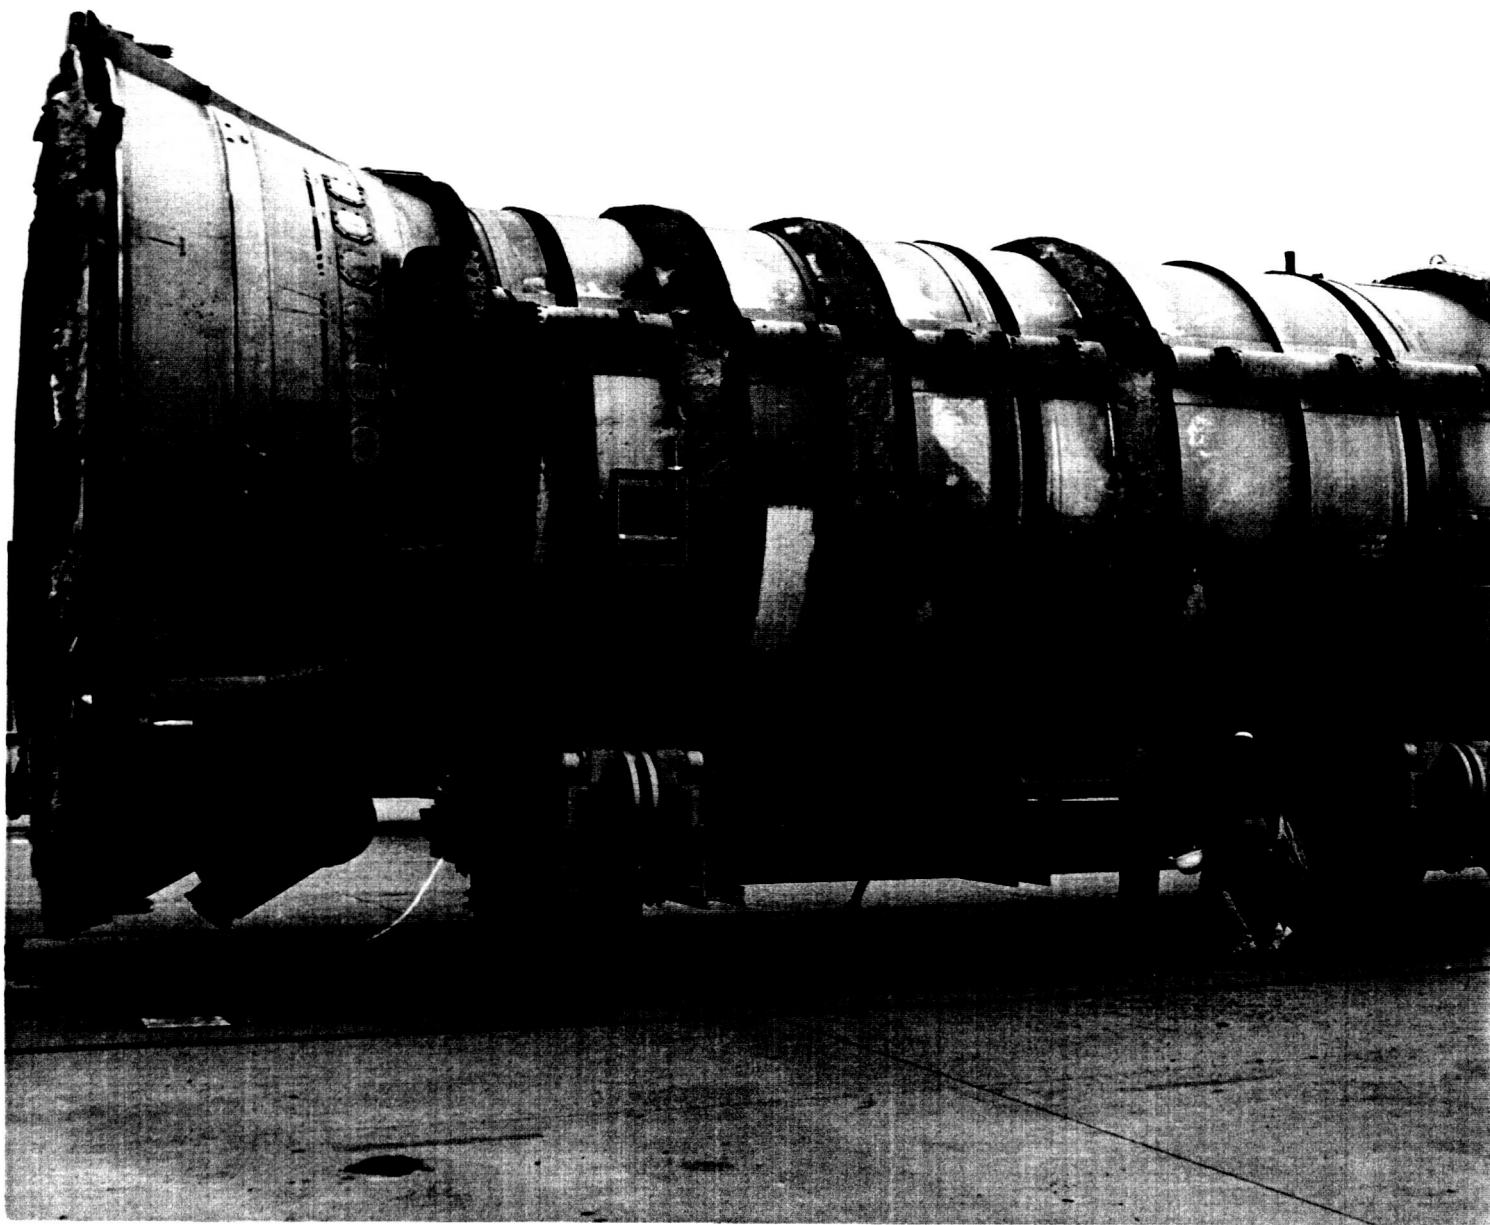
Post flight condition of the LH aft booster/aft skirt. The aft skirt acreage TPS was sooted but generally in good condition

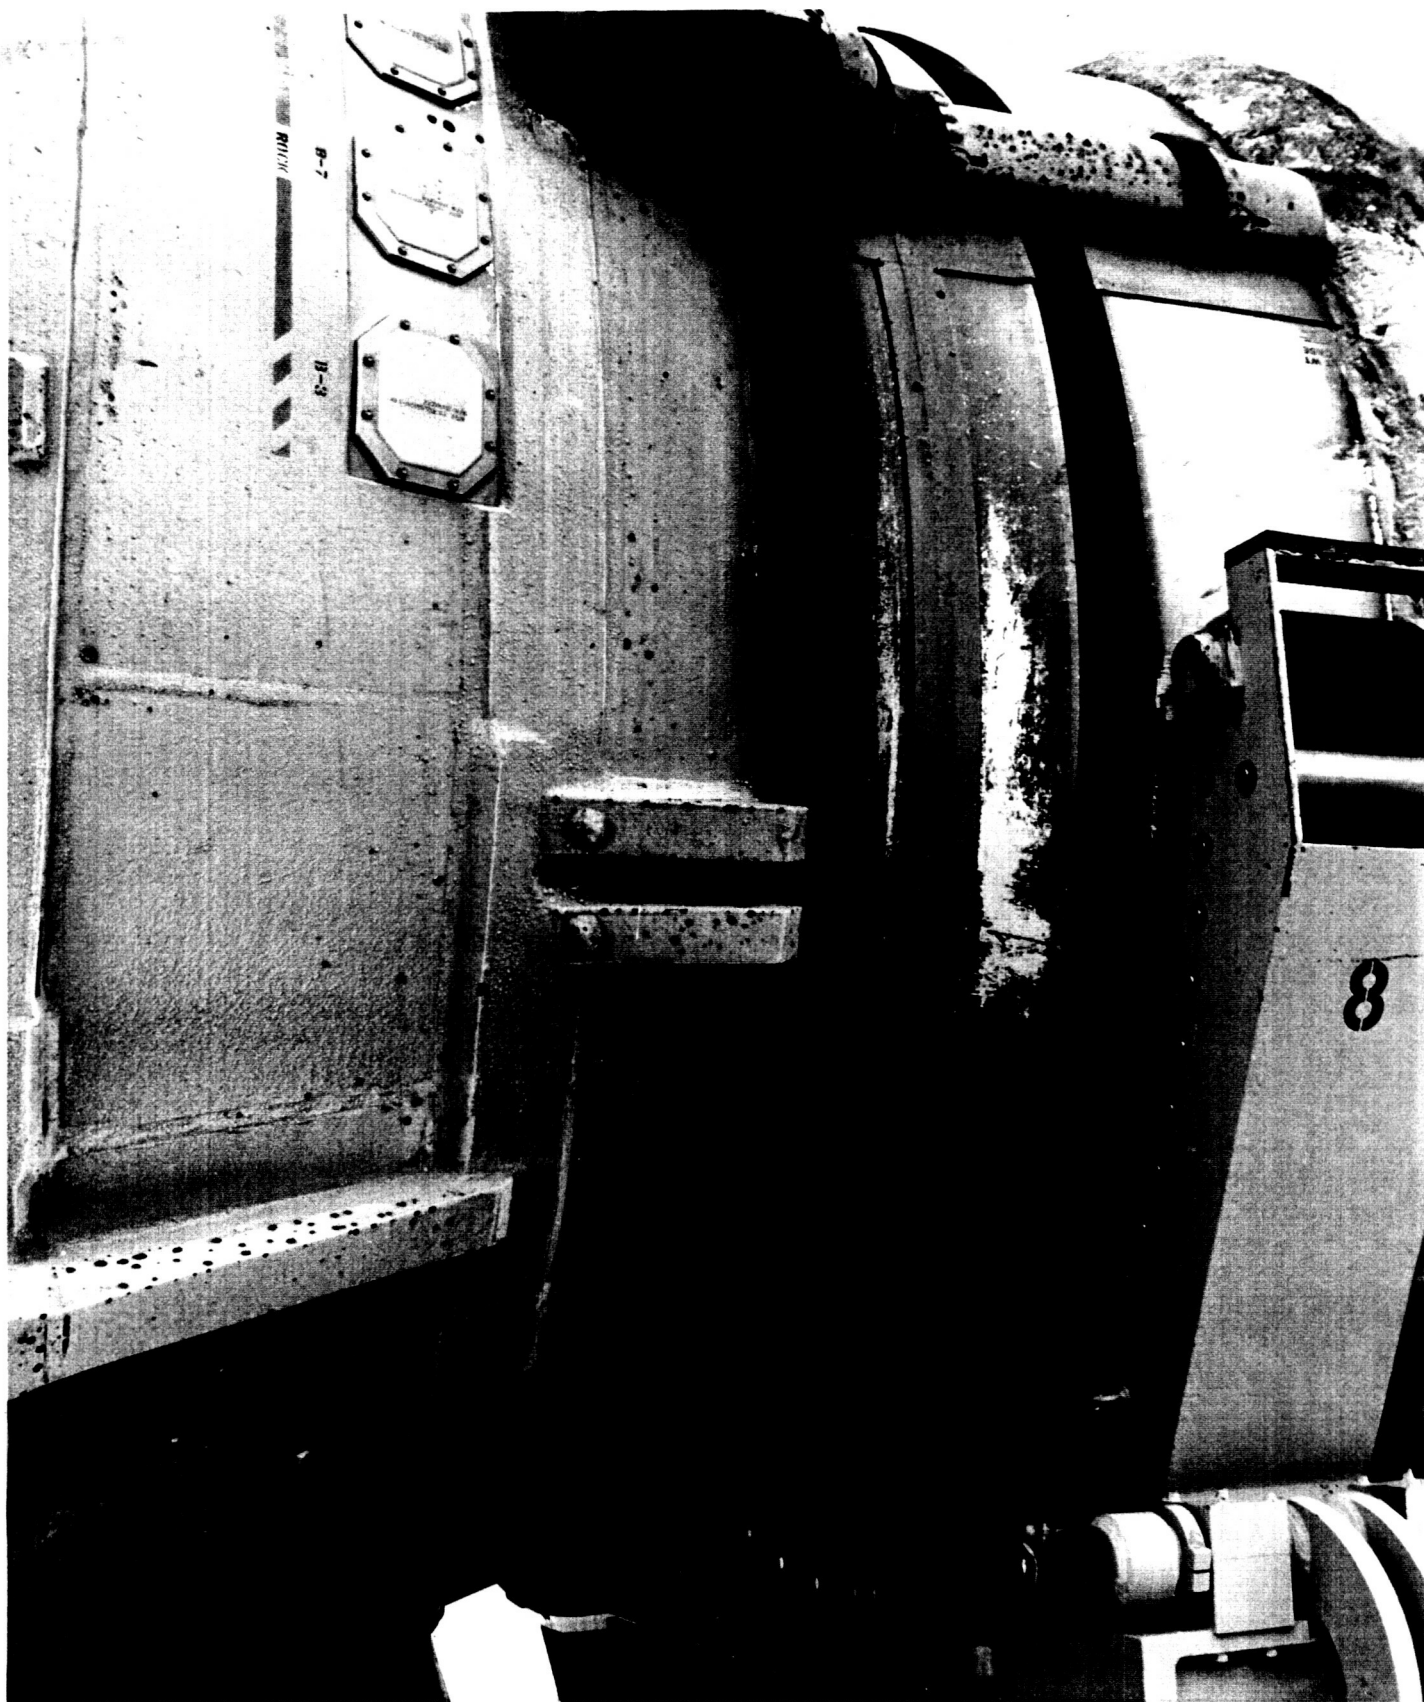
The phenolic material on the kick ring was intact and had not delaminated. K5NA protective domes were missing from bolt heads on the phenolic kick ring prior to water impact. The substrate under the missing domes was sooted.

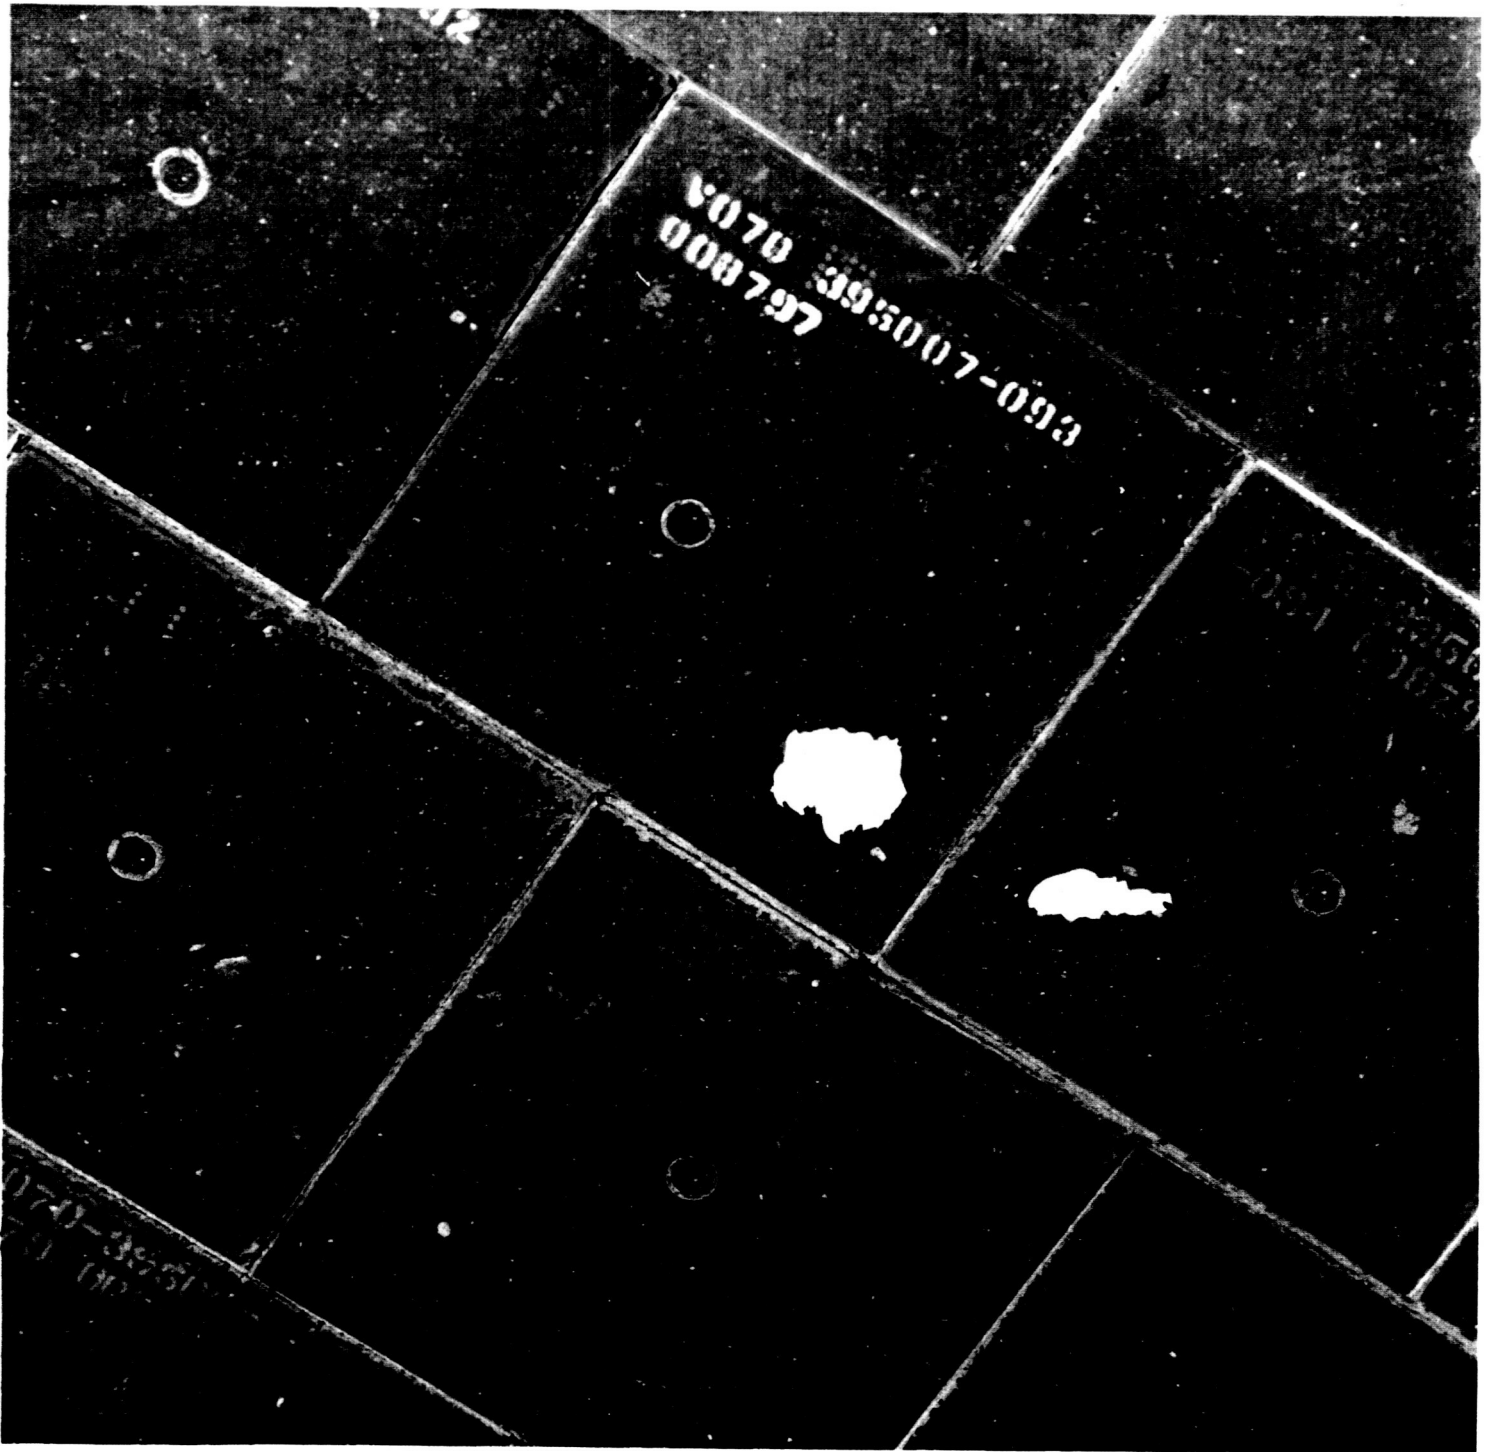
Typical tile damage on the Orbiter lower surface

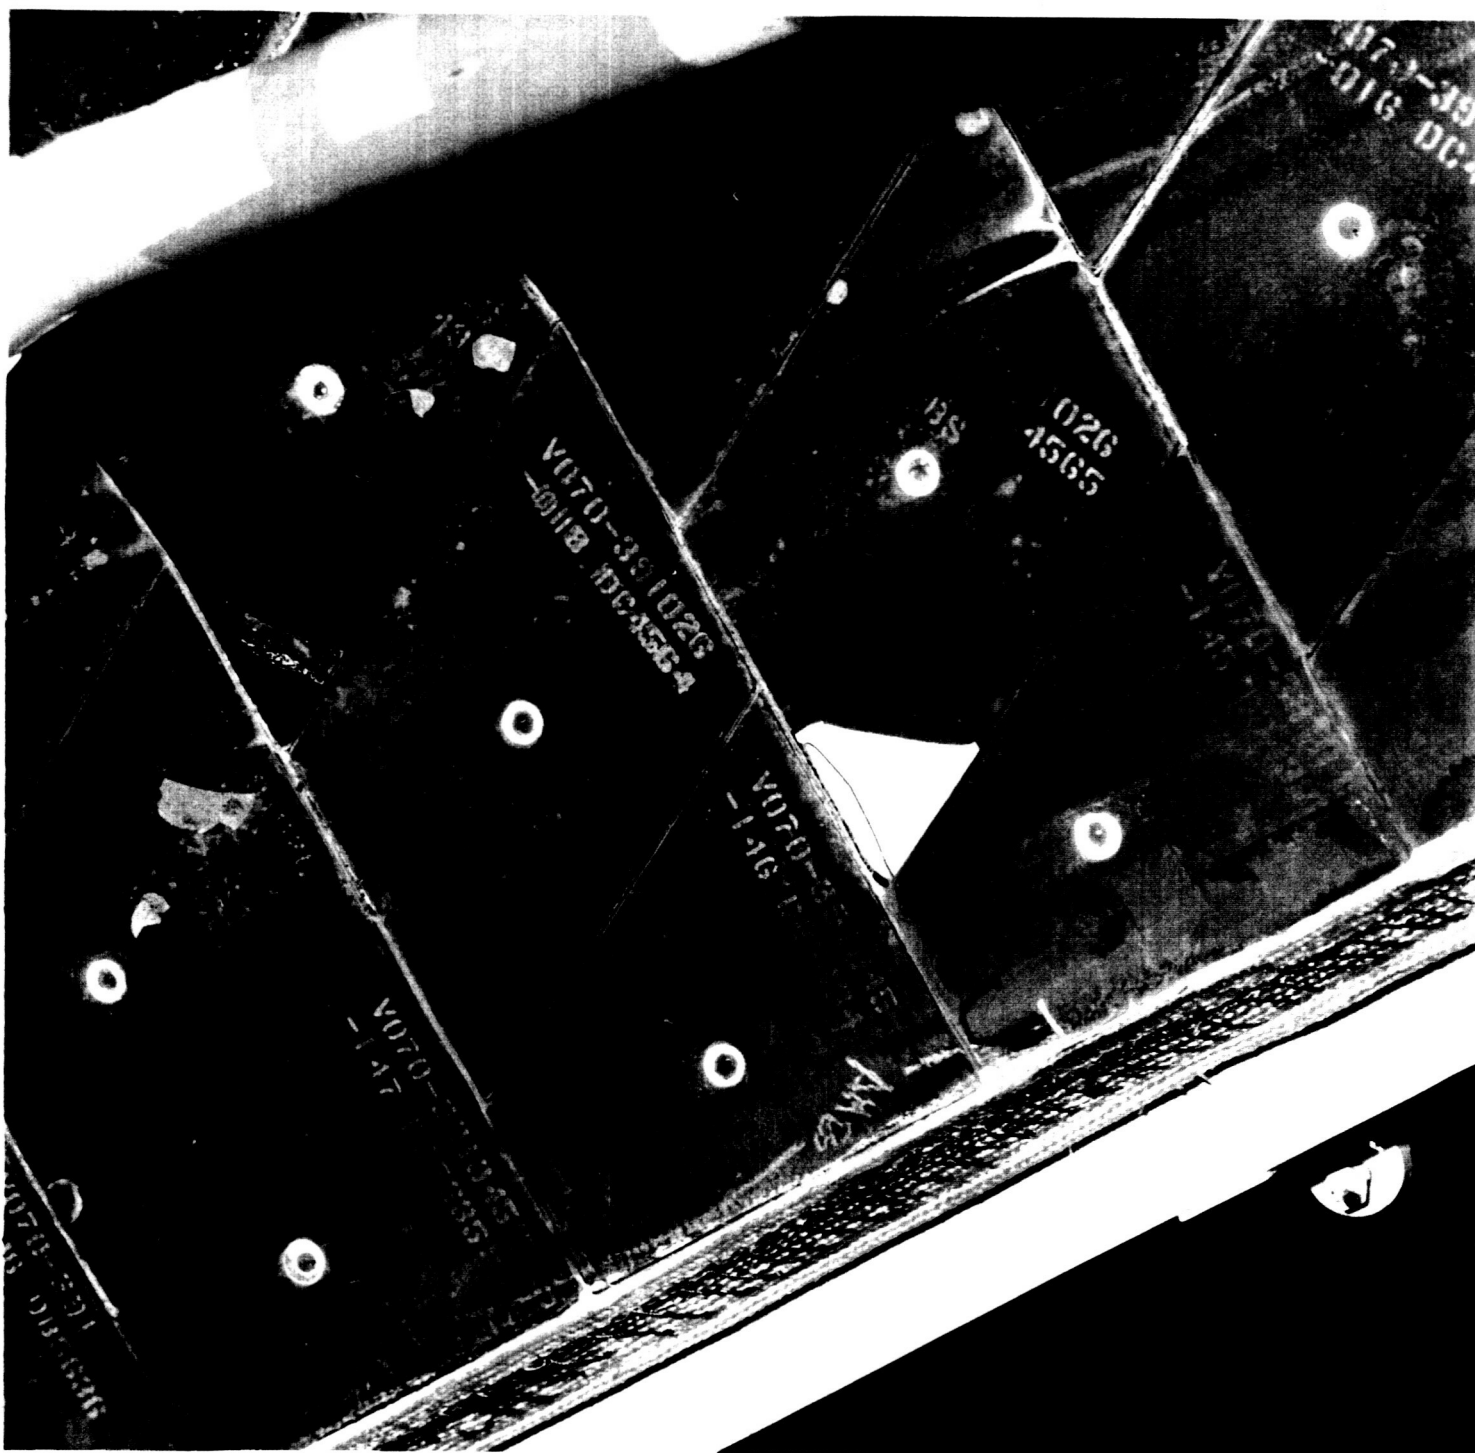
Tile damage on the nose gear door

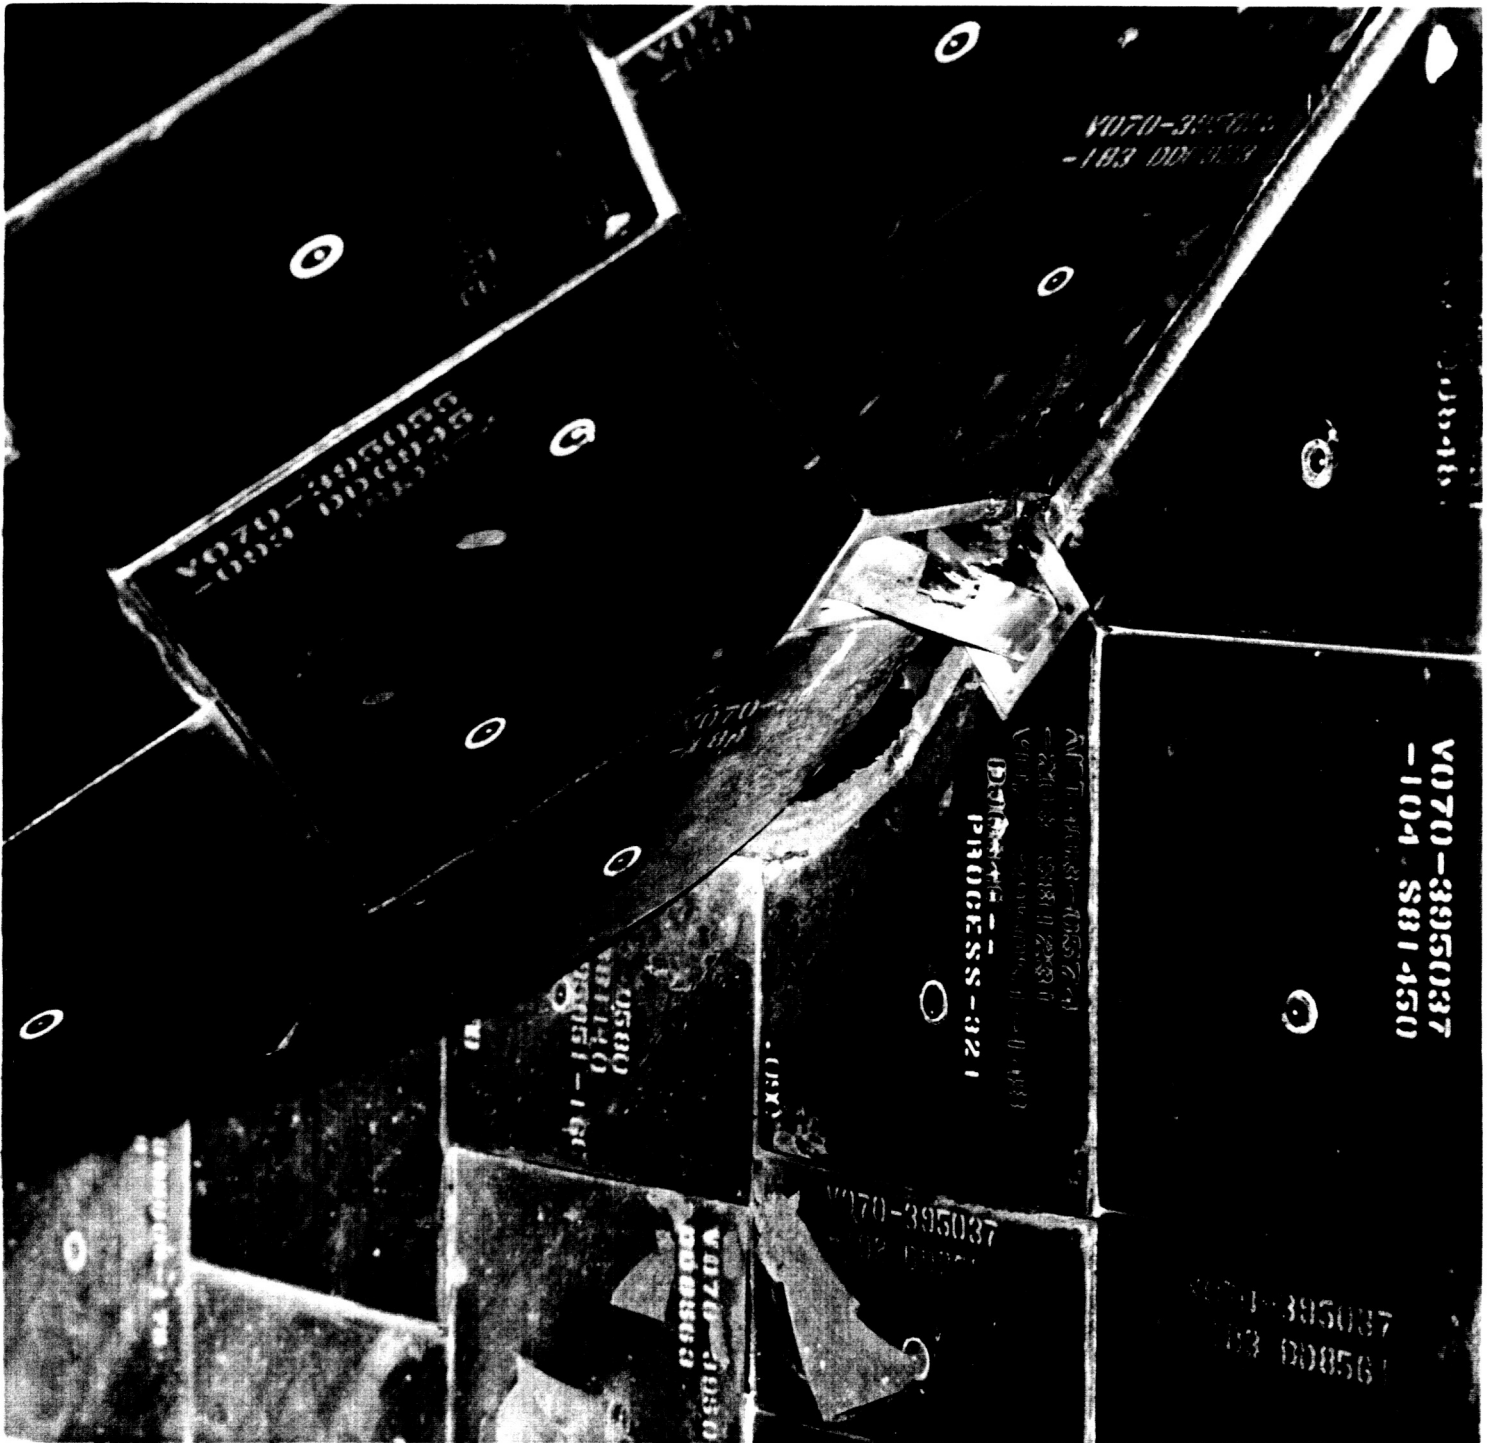
Beta tape adhered to the LO2 ET/ORB umbilical aft door hinge

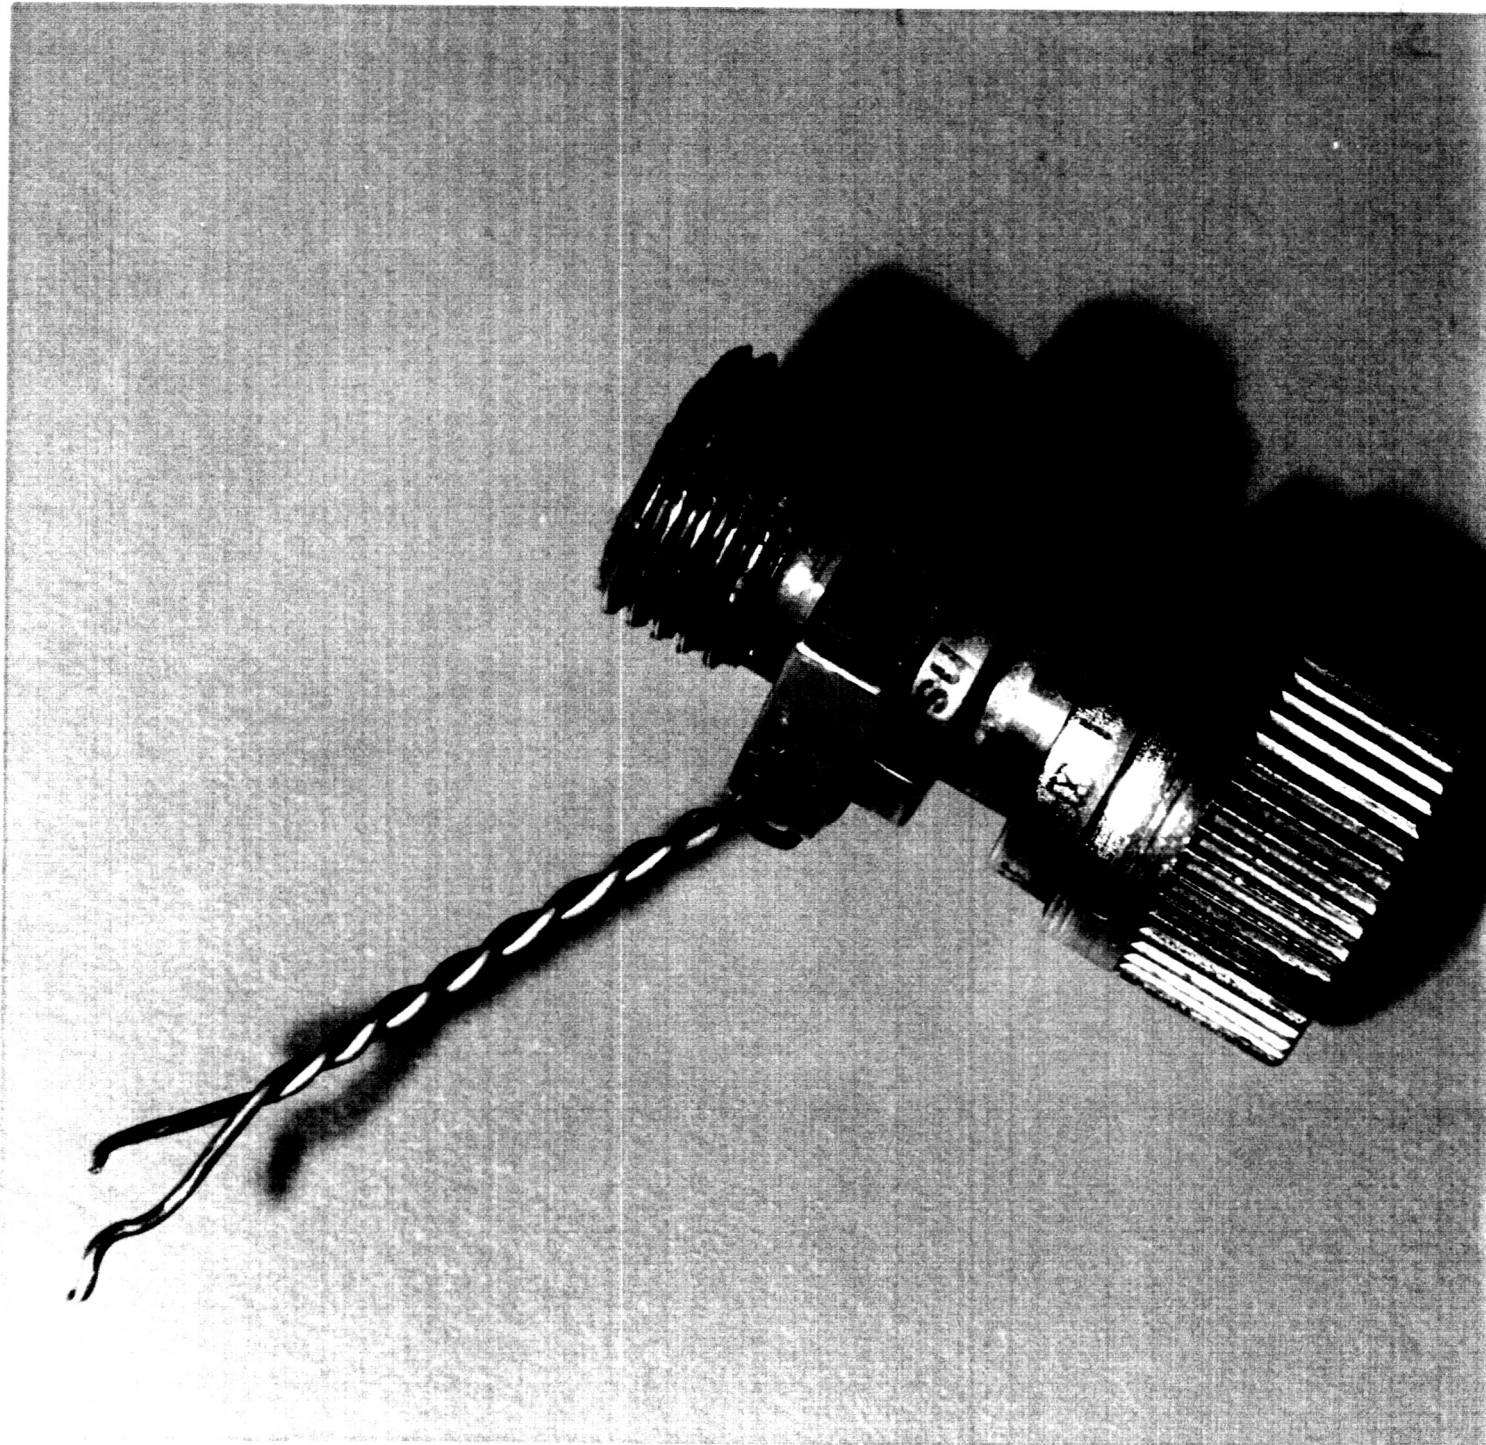
An assembly consisting of an ordnance connector, detonator, and lockwire fell from the ET/ORB LH2 umbilical after the ET doors were opened. Part numbers on the assembly identified it as originating from the LH2 umbilical aft separation device.

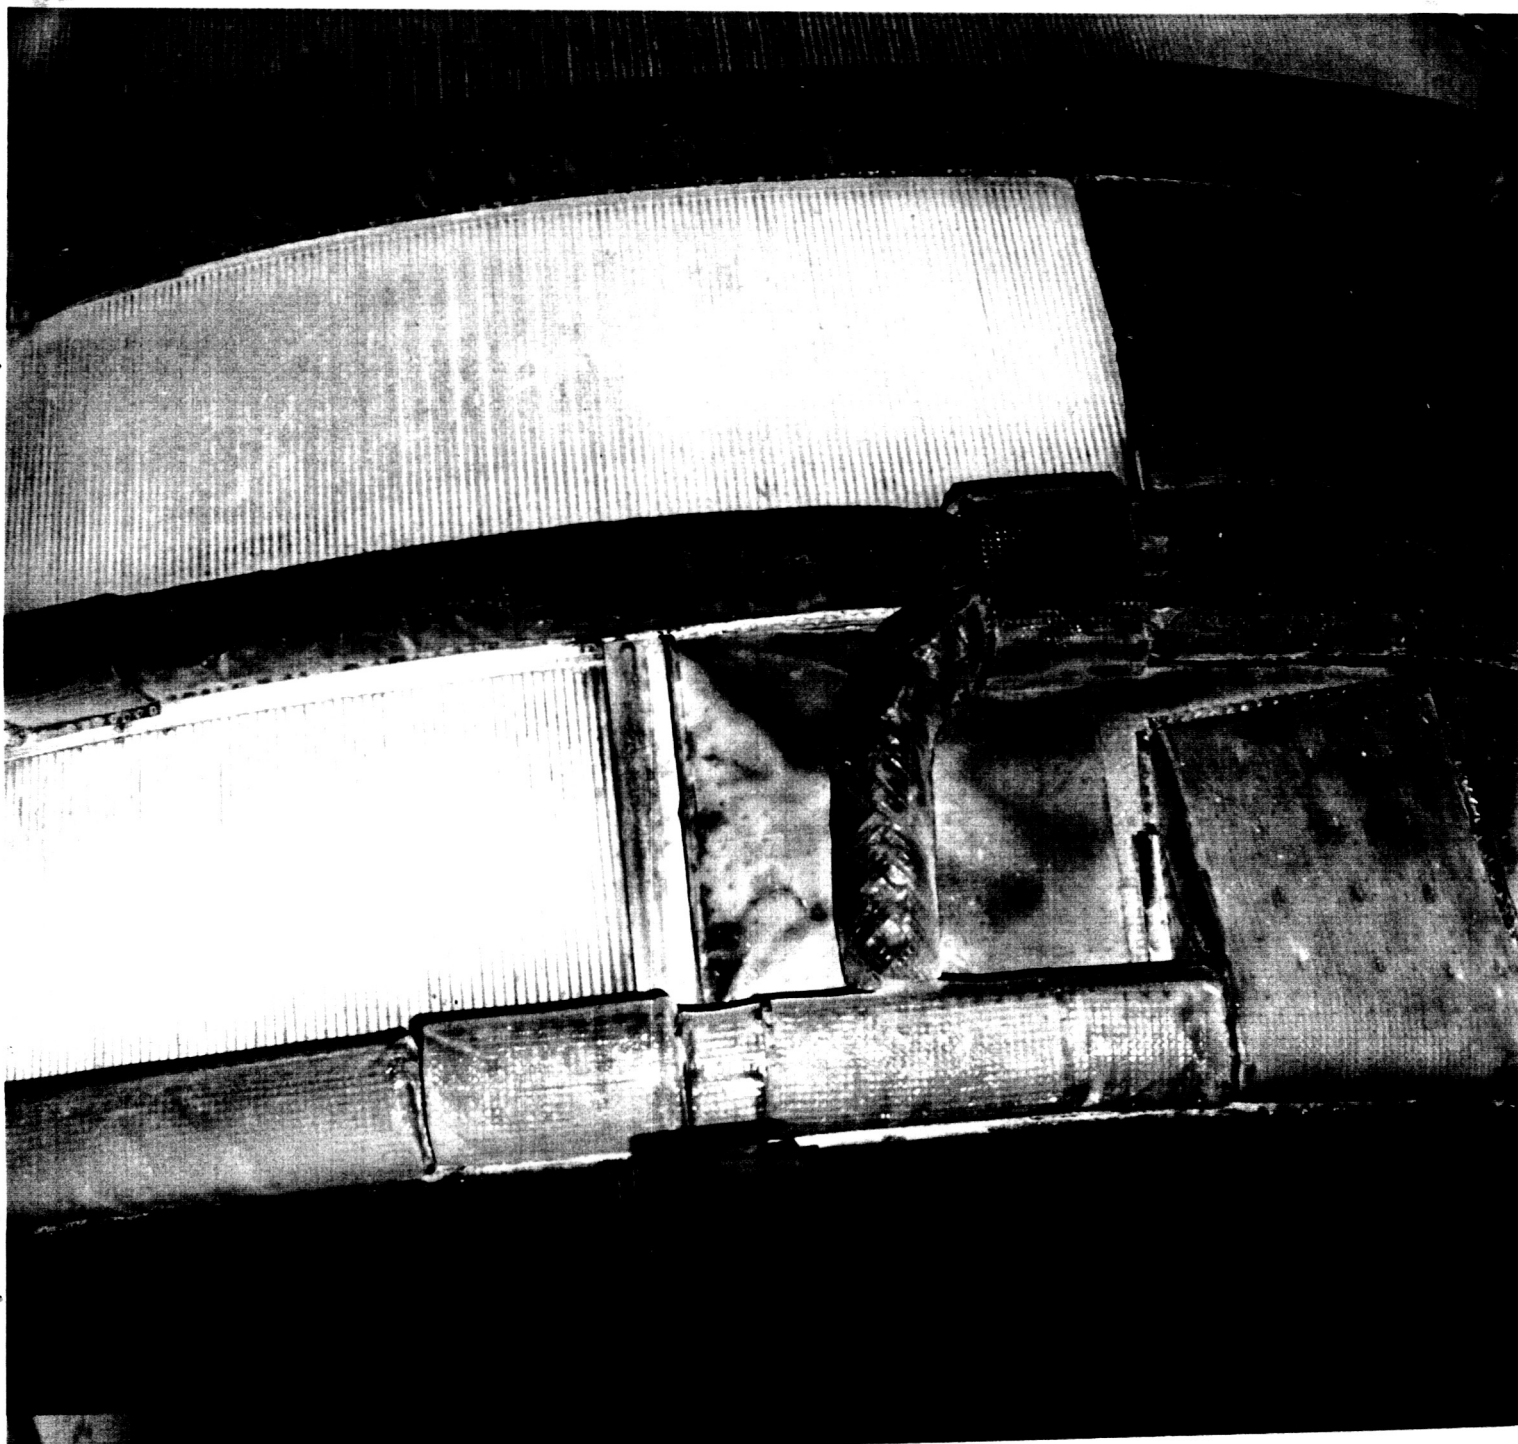
Although liftoff films recorded a small hydrogen leak on the SSME #2 nozzle cold wall near the aft manifold/steer horn, no external damage or burnt insulation was visible.
